BUREAU OF RECLAMATION

# HIGH-PRESSURE RESERVOIR OUTLETS

A REPORT ON

BUREAU OF RECLAMATION INSTALLATIONS

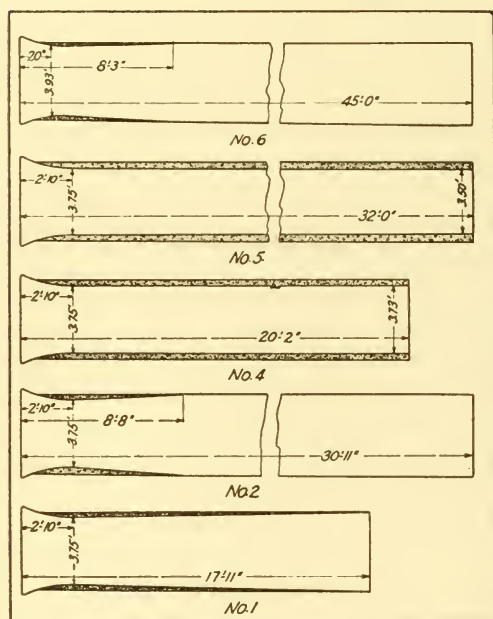
*Valve No. 1.*—The jet was straight and smooth, with no ridges and very little spray. The conduit was not quite full, a segment occurring

FIG. 34.—Experimental conduits, South Tunnel, Pathfinder Dam.

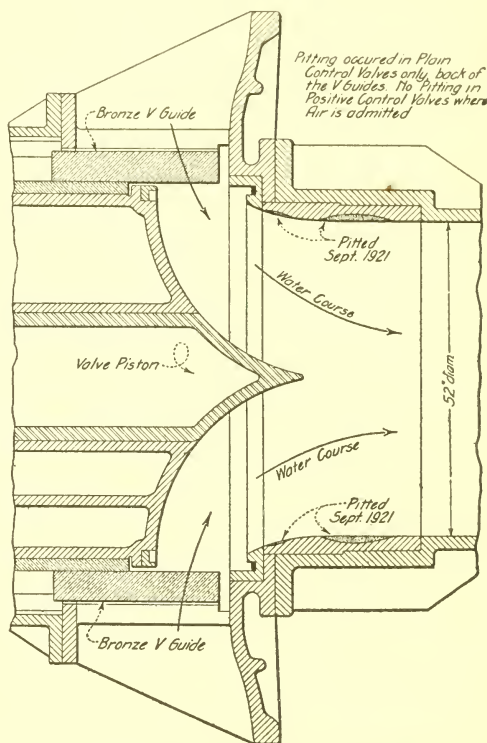
point pitting begins. There was practically no pitting below the air holes. The fact that the positive-control liners are pitted less than those of the plain-control valves also indicates that considerable benefit has been obtained from the admission of air.

No. 18 plain-control valve in the upper tier was in the worst condition of any plain-control outlet. The stationary bronze seat was pitted at top and bottom about  $\frac{1}{16}$  inch deep. The throat piece was pitted at the bottom about 1 inch deep and over an area of about 18 inches in diameter. Almost the entire top half of the liner and the conduit for a few inches below the liner was pitted to a maximum depth of about  $1\frac{1}{2}$  inches. The semisteel linings were not damaged and the concrete was intact. The paint was about half gone from the concrete, but that on the metal linings was nearly intact. The

FIG. 40.—Pittings of upper outlet castings, Arrowrock Dam.
